DETERMINATION OF BONDING PARAMETERS AND INSPECTIC
TECHNIQUES FOR CADMIUM-TO-STAINLESS STEEL BONDS
AND ASSEMBLY OF TWO CAPSULE HOUSINGS

NATIONAL AERONAUTICS AND SPACE ADMINISTRATION
Lewis Research Center

February 28, 1968

Contract No. NAS 3-7892-H

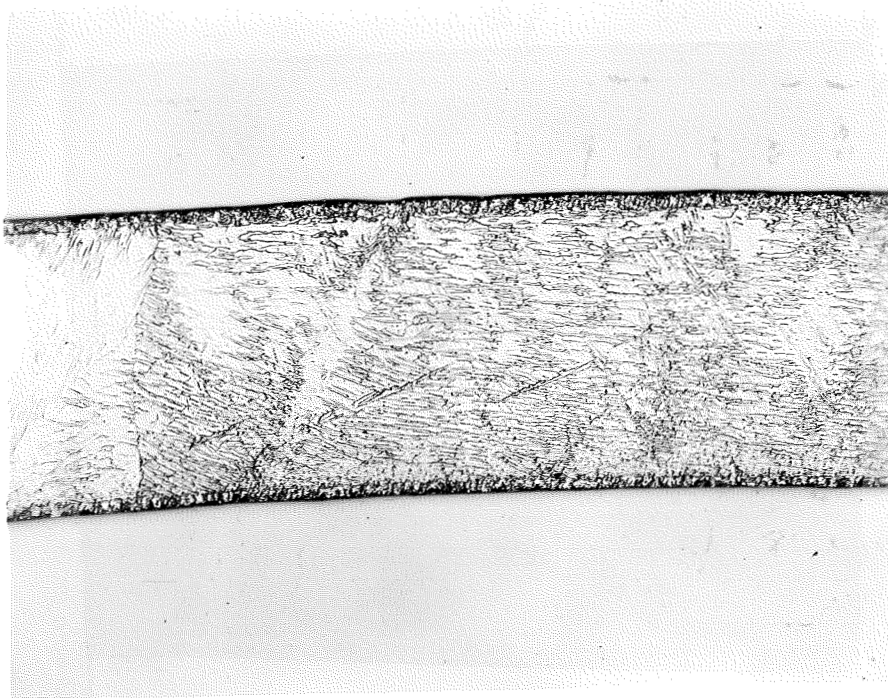
9A441

Metallographic examination showed good bonding of the 0.015-in.-thick cadmium sheet to most of the thin outer tube and to a portion of the OD of the inner tube. This is shown in Figure 1. About one-third of the specimen was bonded on the inner surface, and at the point of maximum separation, a small gap also existed at the outer bond interface as shown in Figure 2. It was evident that good contact of all surfaces had been achieved during the run but that springback of the stainless tube had resulted in the separation. The amount of springback obtained, about 0.001 in., was that which would be expected from annealed stainless steel that had been plastically deformed. The longitudinal joint in the cadmium sheet had been completely closed and was well bonded. This fact would also indicate that good pressure transmission through the thin outer tube had been achieved.

FIGURE 1. WELL BONDED SECTION OF TUBULAR SPECIMEN

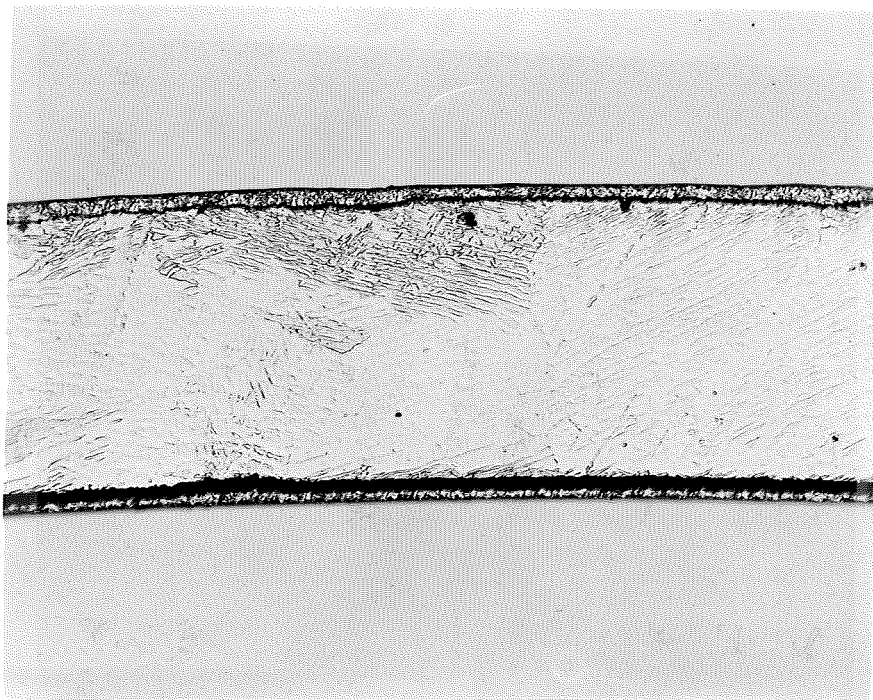
9A442

Bonding runs using cadmium sheet material indicated that a gap existed between the stainless steel and the cadmium due to the elastic springback of the thin outer tube. This springback cannot be avoided if the necessary clearances for assembly are provided. To prevent deformation of the thin outer stainless steel tube during bonding, no clearance may exist in the assembled specimen. The only practical method of accomplishing this is to assemble a heated outer tube over a chilled inner tube. To evaluate this approach, the feasibility of producing a thick cadmium plating free from voids or inclusions was investigated. Studies indicated that a high-quality plating could be obtained in sufficient thickness (over 0.015 in. thick) on the ID of the thin-wall outer tube.

FIGURE 2. SECTION OF TUBULAR SPECIMEN SHOWING
SEPARATION AT PLATING-SHEET
INTERFACE

A specimen to evaluate this approach was prepared and bonded. The ID of the thin outer tube was plated with about 0.020 in. of cadmium. This was then bored to provide a cadmium thickness of 0.015 in. The inner stainless steel part was plated with 0.0005 in. of cadmium over a nickel strike. This then resulted in a 0.001-in. interference fit between the two parts. The outer part was heated to 200 F and the inner part chilled in liquid nitrogen. The parts were then assembled, outgassed at 220 F for 30 min, and sealed by welding. Following helium leak check, the specimen was bonded at 500-550 F at a gas pressure of 2200 psi. Following bonding, the specimen was ultrasonically inspected, and the only defect noted was a void in the plating that was apparent prior to assembly. This defect area was slightly thicker than the rest of the plated surface and chipped out during machining. The specimen was metallographically examined and found to be well bonded with no separation in any area. Photomicrographs of the bonds obtained are shown in Figure 3. The only area that appeared to contain contamination at the bond zone was near the ends where possible overheating due to welding may have occurred. The use of this approach eliminated any separation after bonding.

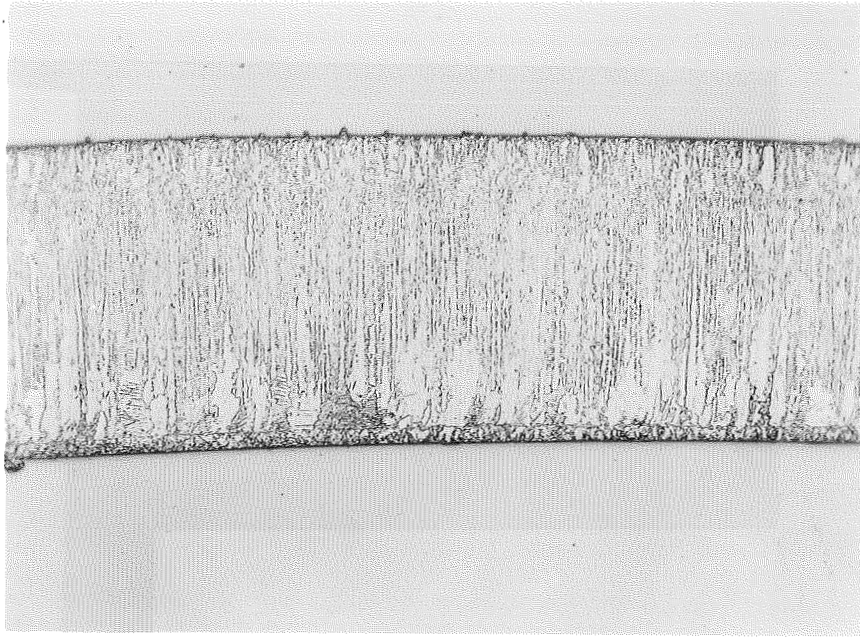
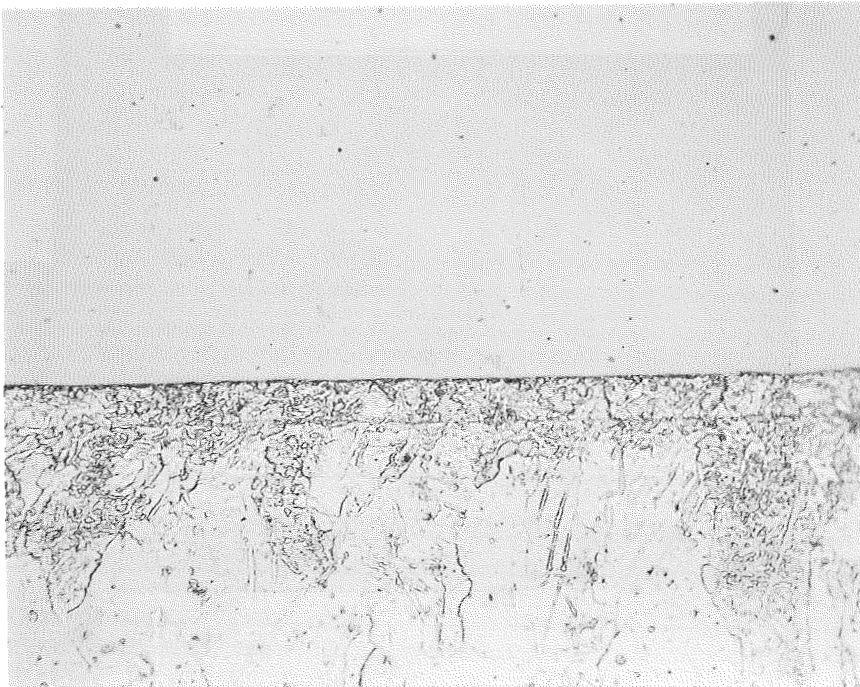
FIGURE 3. WELL BONDED TUBULAR SPECIMEN

This specimen was assembled so that at 0.001 in interference fit existed between the thin outer tube and the inner tube.

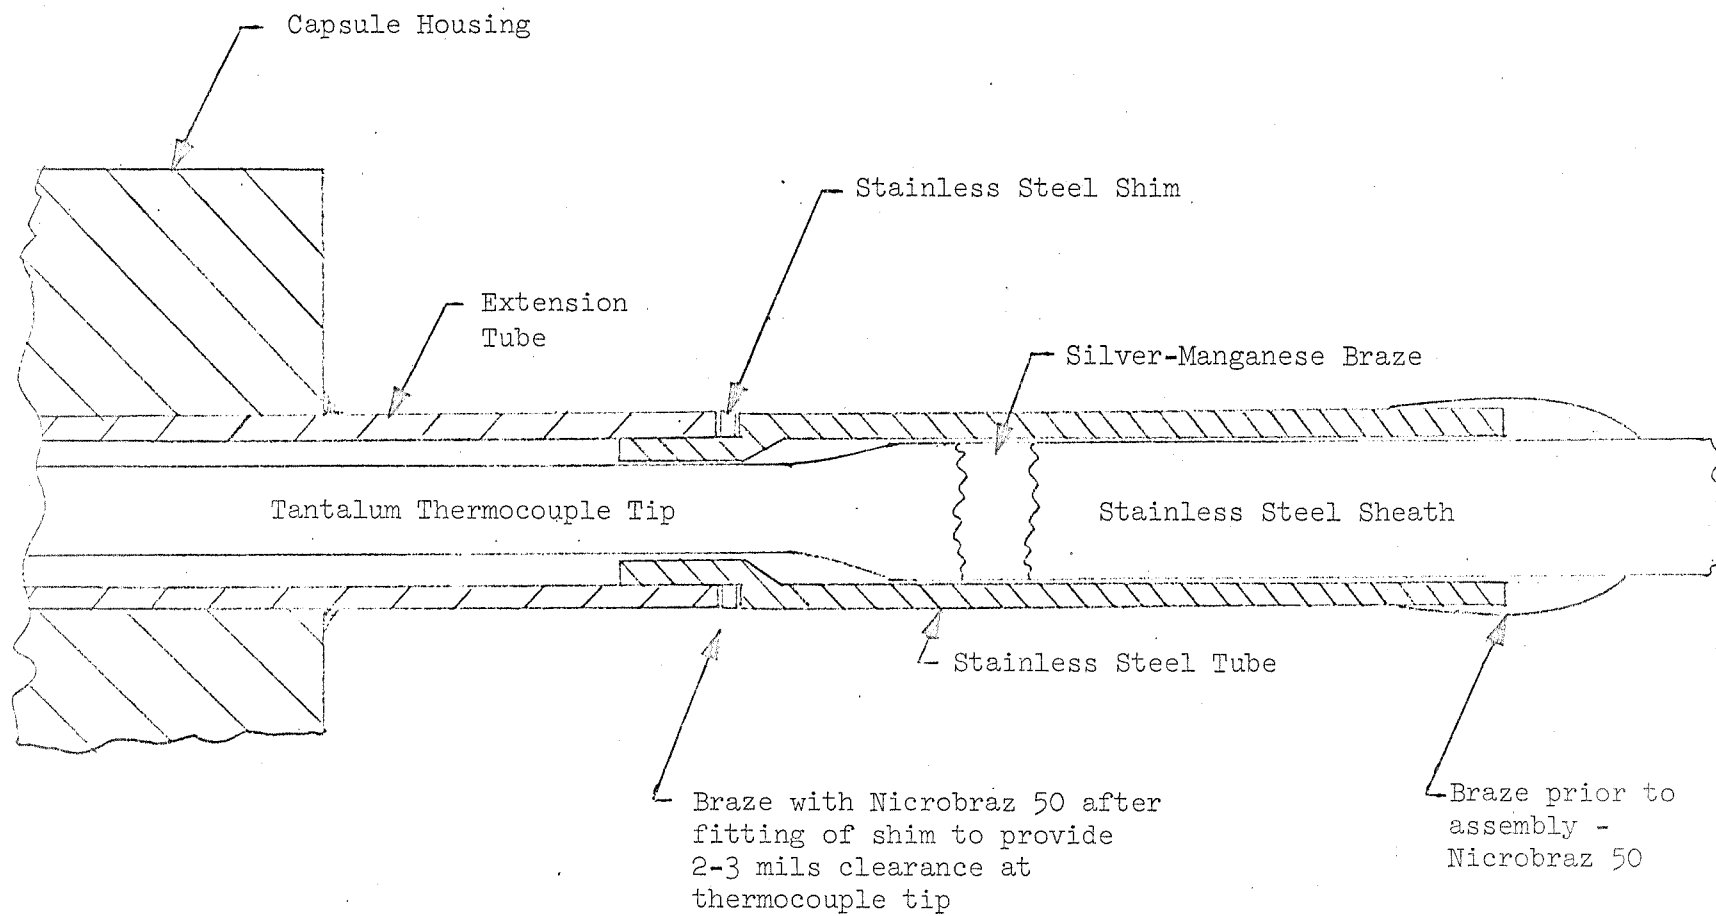
Techniques were developed whereby the new thermocouples for Assembly 3A could be positioned so that a gap of 2-3 mils existed between the tip of the thermocouple and bottom of the thermocouple well. This is shown in Figure 4. The first joint brazed was between the stainless steel tube and the thermocouple sheath. This was accomplished by localized heating of the brazing area in an electron-beam welder. A defocused beam was used to prevent melting of the stainless steel thermocouple sheath. A copper chill block was used to prevent overheating of the braze joint between the tantalum tip and the stainless steel sheath. Metallographic examination of brazed specimens indicated that no melting of this internal braze joint had occurred. Some erosion of the stainless steel sheath was noted on the side heated by the electron beam. This erosion extended into the sheath about 0.004 in. or about one-third the sheath thickness. Braze metal filled this eroded area however, and the integrity of the couple would not

FIGURE 4. THERMOCOUPLE POSITIONING TECHNIQUE

The thermocouples were then brazed into Assembly 3A using a defocused electron beam as a heat source. The thermocouples were positioned with stainless steel foil shims to maintain a 0.002- to 0.003-in. clearance between the tip of the thermocouple and the bottom of the well. It was anticipated that only one brazing operation would be required for the attachment of each thermocouple. However, additional cycles were necessary to provide a leak-tight joint. This was probably caused by the large heat sink provided by the capsule assembly. In most cases, it appeared that the braze material did not flow adequately on the extension tube extending from the capsule assembly. Good flow of the braze was noted in all cases on the stainless steel tube brazed onto the thermocouple sheath in a previous operation. The requirement of more than one brazing operation caused a decrease in the clearance between the tip of the thermocouple and the bottom of the well. Apparently, alloying of the liquid braze with the stainless steel components resulted in a reduction of the effective thickness of the shim materials. Measurements to determine the clearance between the tip of the thermocouple and the bottom of the well were taken and are listed in the Appendix.

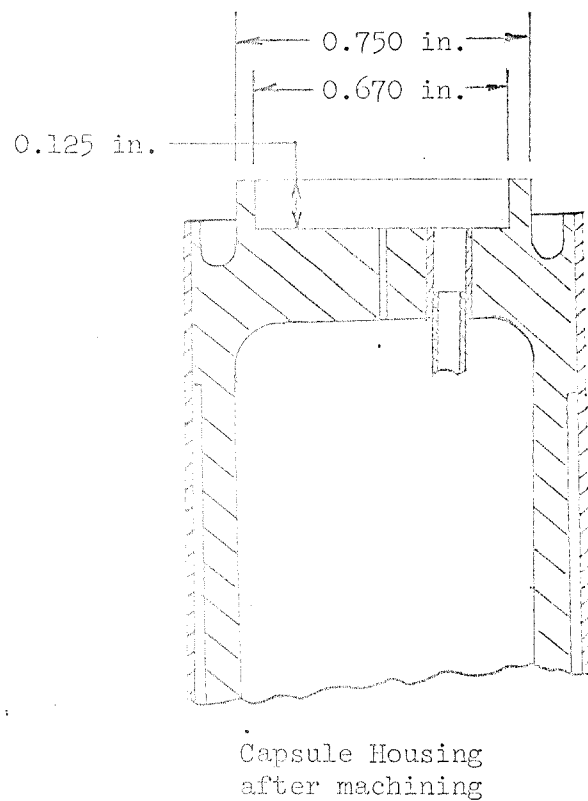
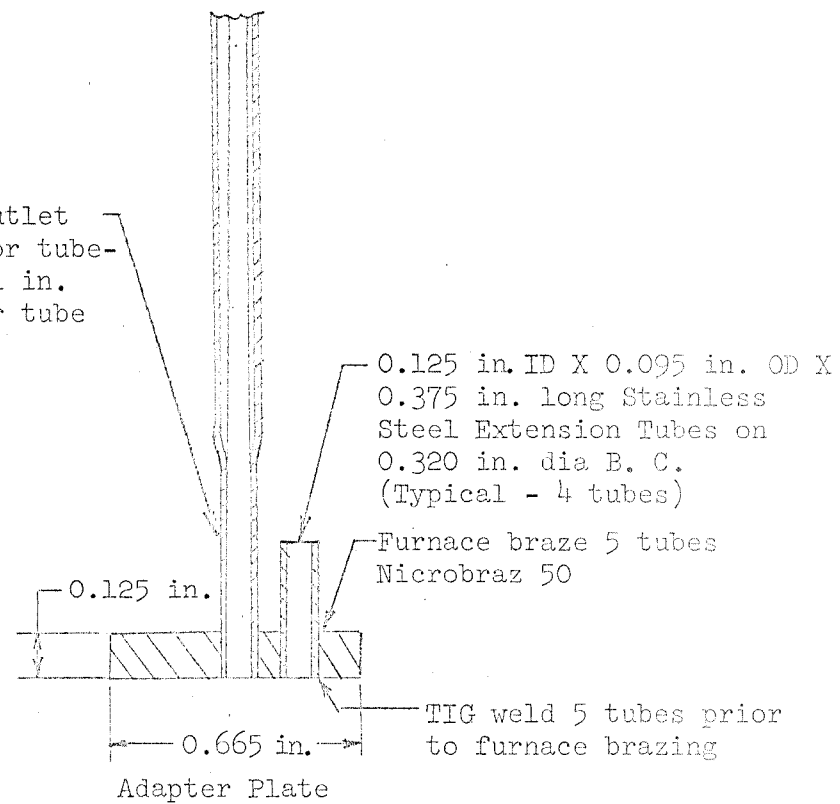
The procedures used for the brazing of the thermocouples into Assembly 4A were the same as those described above for Assembly 3A. Leak checking of the assembly showed that there were leaks on Thermocouples M and R at the braze joint of the thermocouple well extension to the capsule housing. This leak was directly above the leak hole to the thermocouple well which is 0.035 in. below the surface of the capsule housing. Brazing with a tungsten arc in an inert gas chamber was used as a means of attempting to seal these leaks. This approach did not prove satisfactory in sealing the leaks completely. Although satisfactory brazes were obtained in accessible areas, the thermal stresses caused by brazing in this manner appeared to cause cracking of the braze in areas that could not be reached with the TIG unit.

FIGURE 5. PROCEDURES USED IN REWORK OF ASSEMBLY 4A

Additional work was authorized to rework the assembly. The plan for this work involved the removal of the thermocouples, counterboring of the capsule housing, and welding of an adapter plate containing the outlet tube and thermocouple well extensions into the counterbored housing. These procedures are shown in Figure 5. This technique assures an atmosphere in the thermocouple wells. In Figure 6 is shown the method used for brazing of the thermocouples to the housing. This procedure was modified slightly from that used previously to remove the positioning shims from the braze area so that dimensional changes in the clearance between the tip of the thermocouple and the bottom of the well would be minimized. The electrical continuity of the thermocouples and leak tightness of the braze joints were checked in the same manner as that described for Assembly 3A. The pertinent information concerning this assembly is given in the Appendix.

Swage exterior outlet
tube onto interior tube-
0.105 in. dia X 1 in.
TIG weld exterior tube
to interior tube

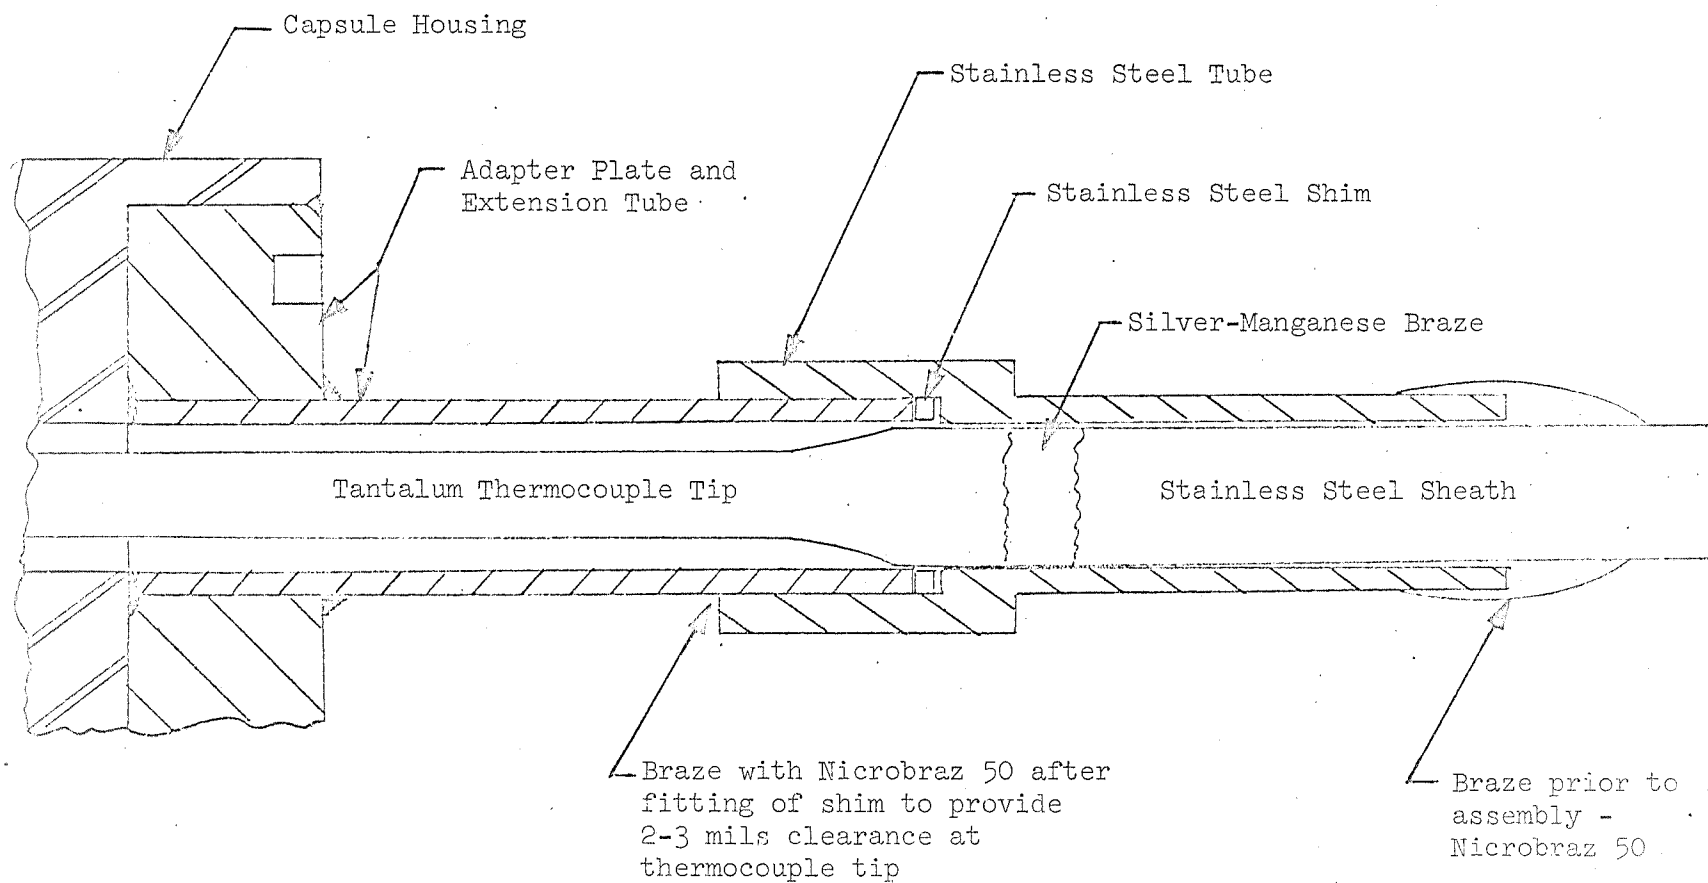
FIGURE 6. THERMOCOUPLE BRAZING TECHNIQUE USED ON ASSEMBLY 4A

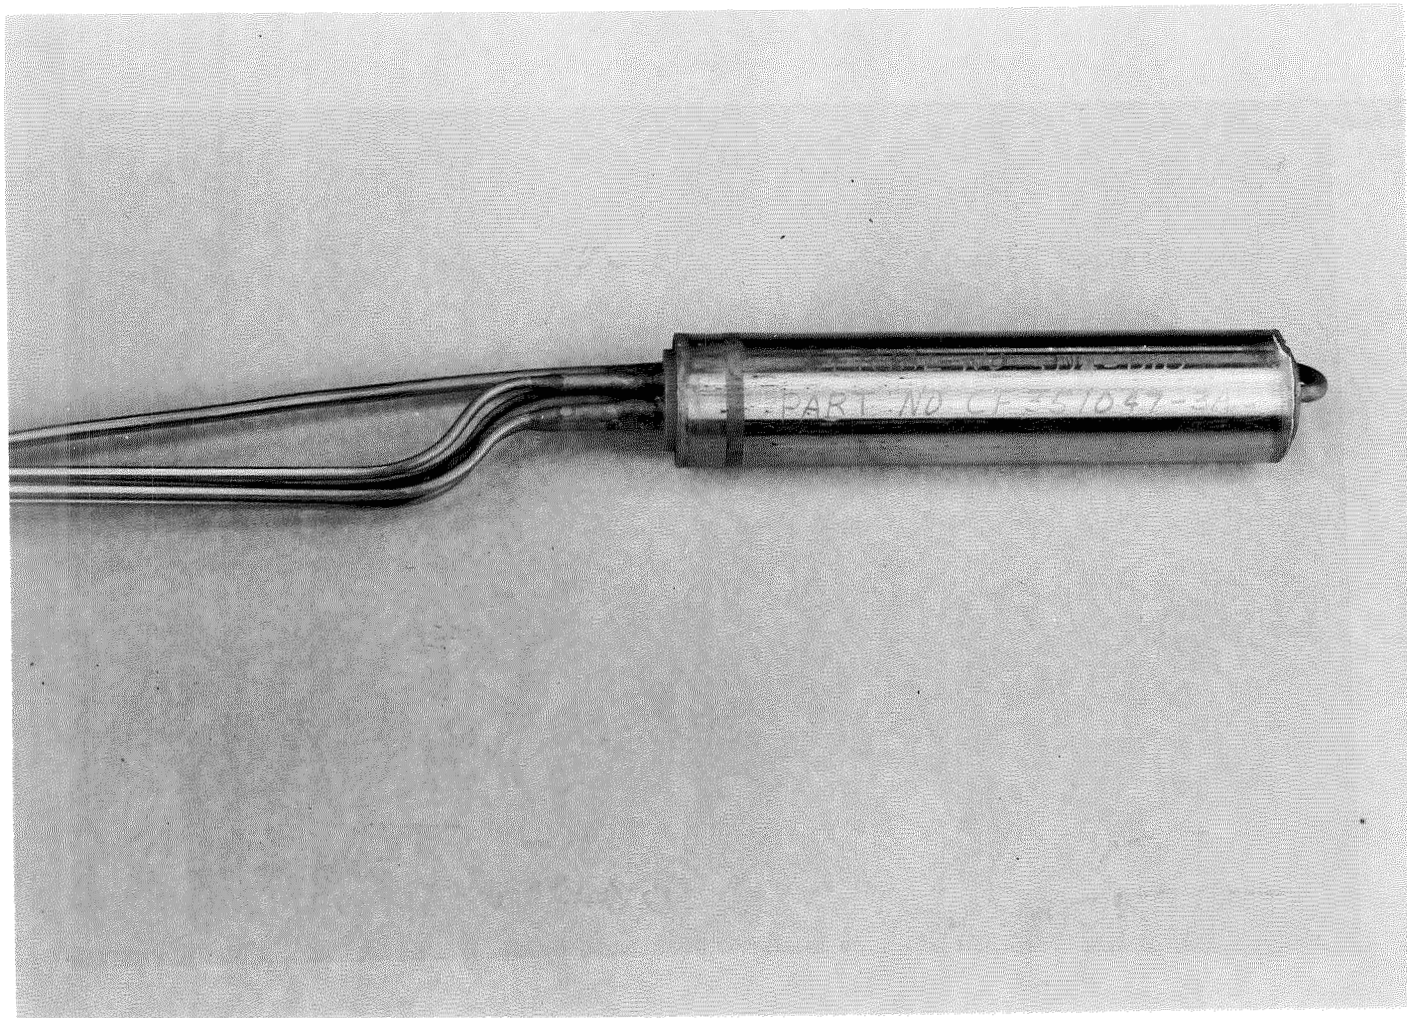
41077

FIGURE 7. CAPSULE HOUSING ASSEMBLY 3A

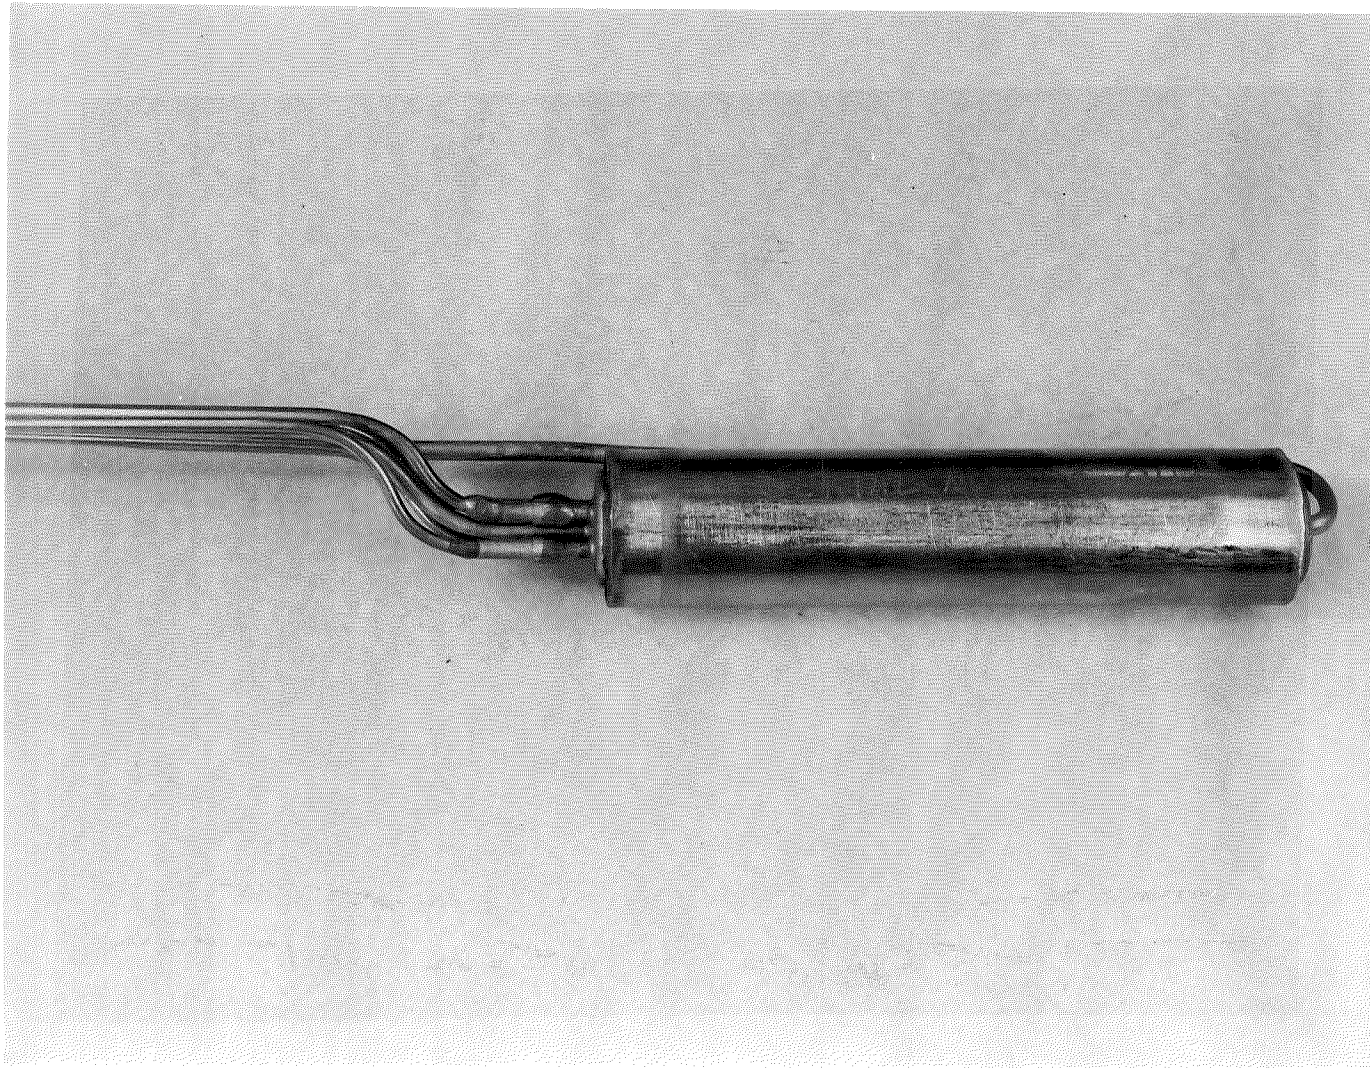
41075

FIGURE 8. CAPSULE HOUSING ASSEMBLY 4A
